DATE: June 22, 2007
TO: Don Bussey, U.S. EPA/ERT Work Assignment Manager
THROUGH: Parry Bhambra, REAC Operation Section Manager *PB*
FROM: Jon McBurney, REAC Task Leader *JMB 6/22/07*
SUBJECT: FIELD ACTIVITIES (MARCH 26 - 30, 2007 and MAY 22, 2007)
BARITE HILL GOLD MINE, MCCORMICK, SC
WORK ASSIGNMENT NO. 0-247 - TRIP REPORT

A. BACKGROUND

The Barite Hill Gold Mine is an inactive gold mine located approximately three miles south of McCormick, South Carolina (SC). The mine actively mined gold from 1991 to 1995. Between 1995 and 1999, the site was undergoing reclamation activities under the direction of Nevada Goldfields. In 1999, Nevada Goldfields filed for bankruptcy and the site has been under the control of the South Carolina Division of Health and Environmental Control (SCDHEC) since then.

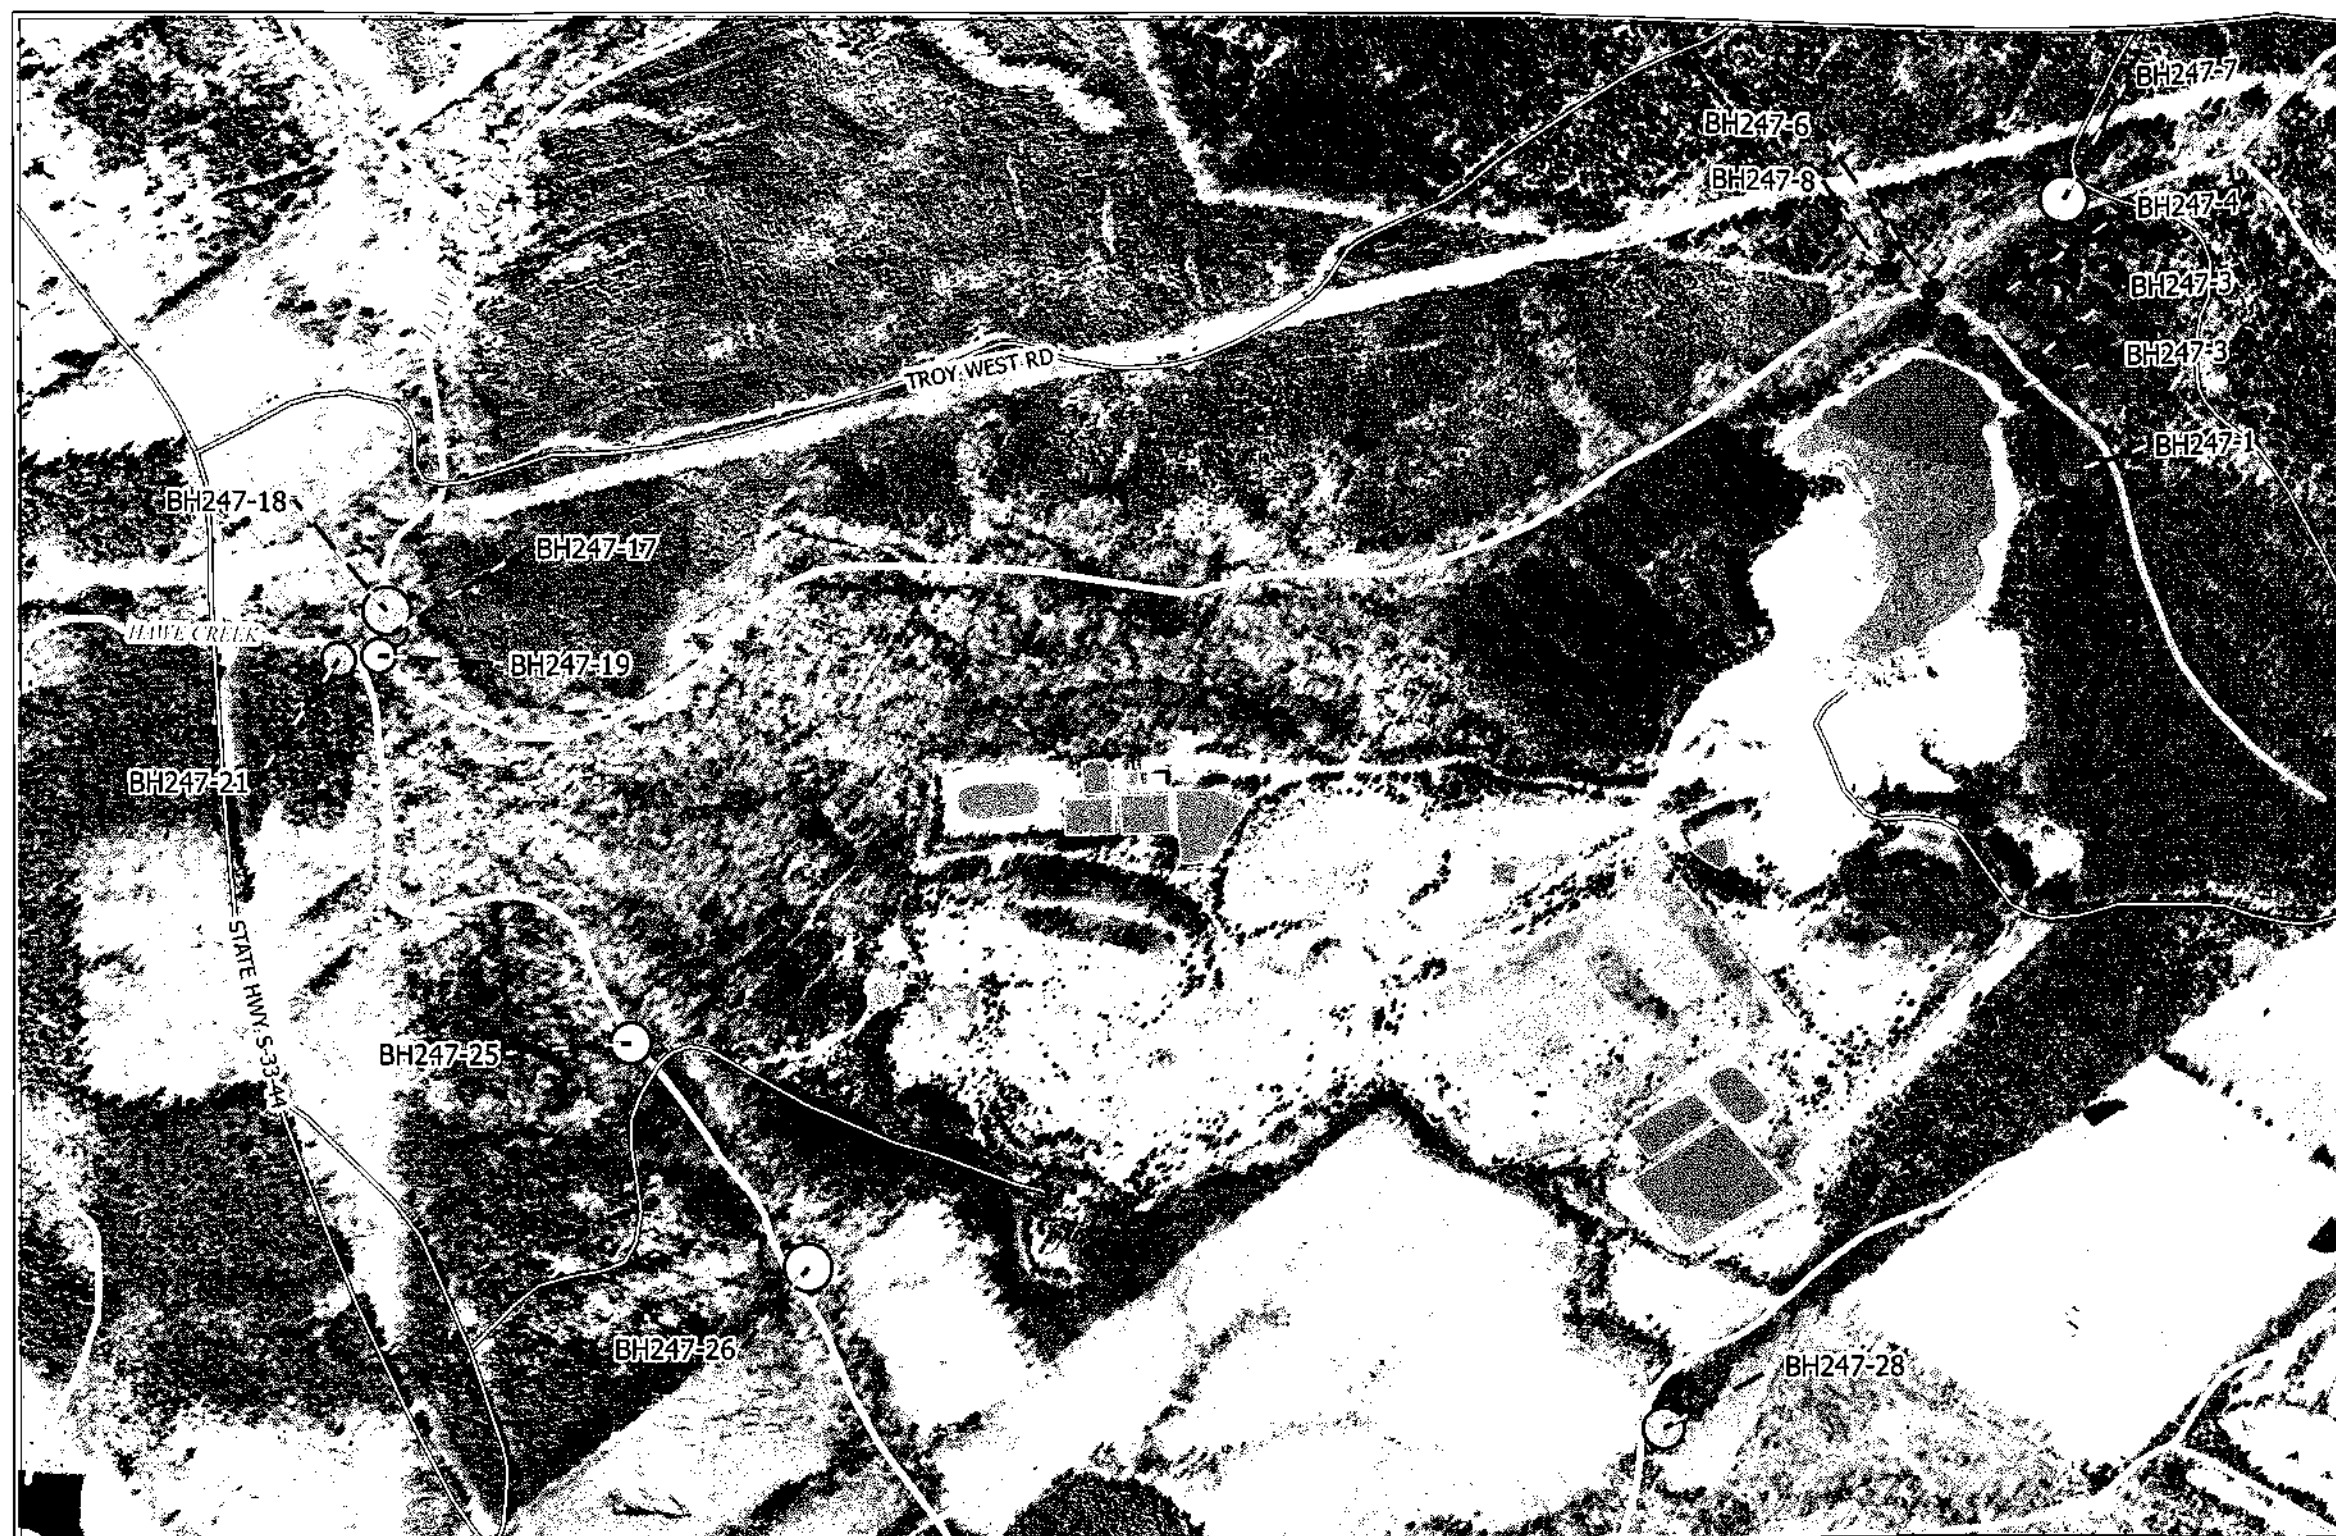
Figure 3
Benthic Diversity Map
Barite Hill
Gold Mine Site
McCormick Co., SC

Other possible reasons for low overall abundance and diversity downstream of the seep are water chemistry and influence from the seep. Chemistry of water and sediment provides more apparent results. Water quality measurements taken during the investigation are detailed in Table 2 with the full analytical report attached as Appendix B. Nitrate and Sulfate screening values are provided in Table 3. TAL Metals and Cyanide analysis results for the stream sediment samples are listed in Table 4. The extremely low pH (pH 2.76) and high Sulfate content (> 200 milligrams/Liter (mg/L)) found after the seep area at location BH247-9 are the indicators of the impact from the main pit. Analytical results indicate that the streams metals content is consistent throughout. The sulfate content and low pH seem to indicate that the sulfate rich low pH water from the Main pit is indeed seeping into and impacting the stream. The impact area can be seen on the pH Map (Figure 4) And the Bioassessment Map (Figure 3).

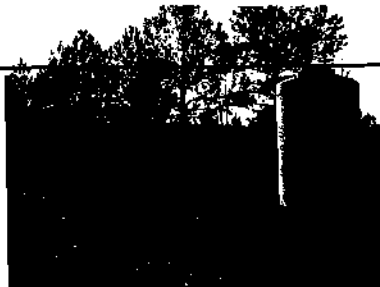
Tank T-1 - Approximately 5,000 gallon capacity. Insulated. Unknown quantity remaining in tank. White powder noted at discharge connection.

Picture 26
Tank T-1
- Taken March 27, 2007
